Total Land Subsidence in the Elfrida Area, Cochise County
Based on Sentinel-1 Satellite Interferometric Synthetic Aperture Radar (InSAR) Data
Time Period of Analysis: 5.0 Years 02/24/2017 To 01/29/2022

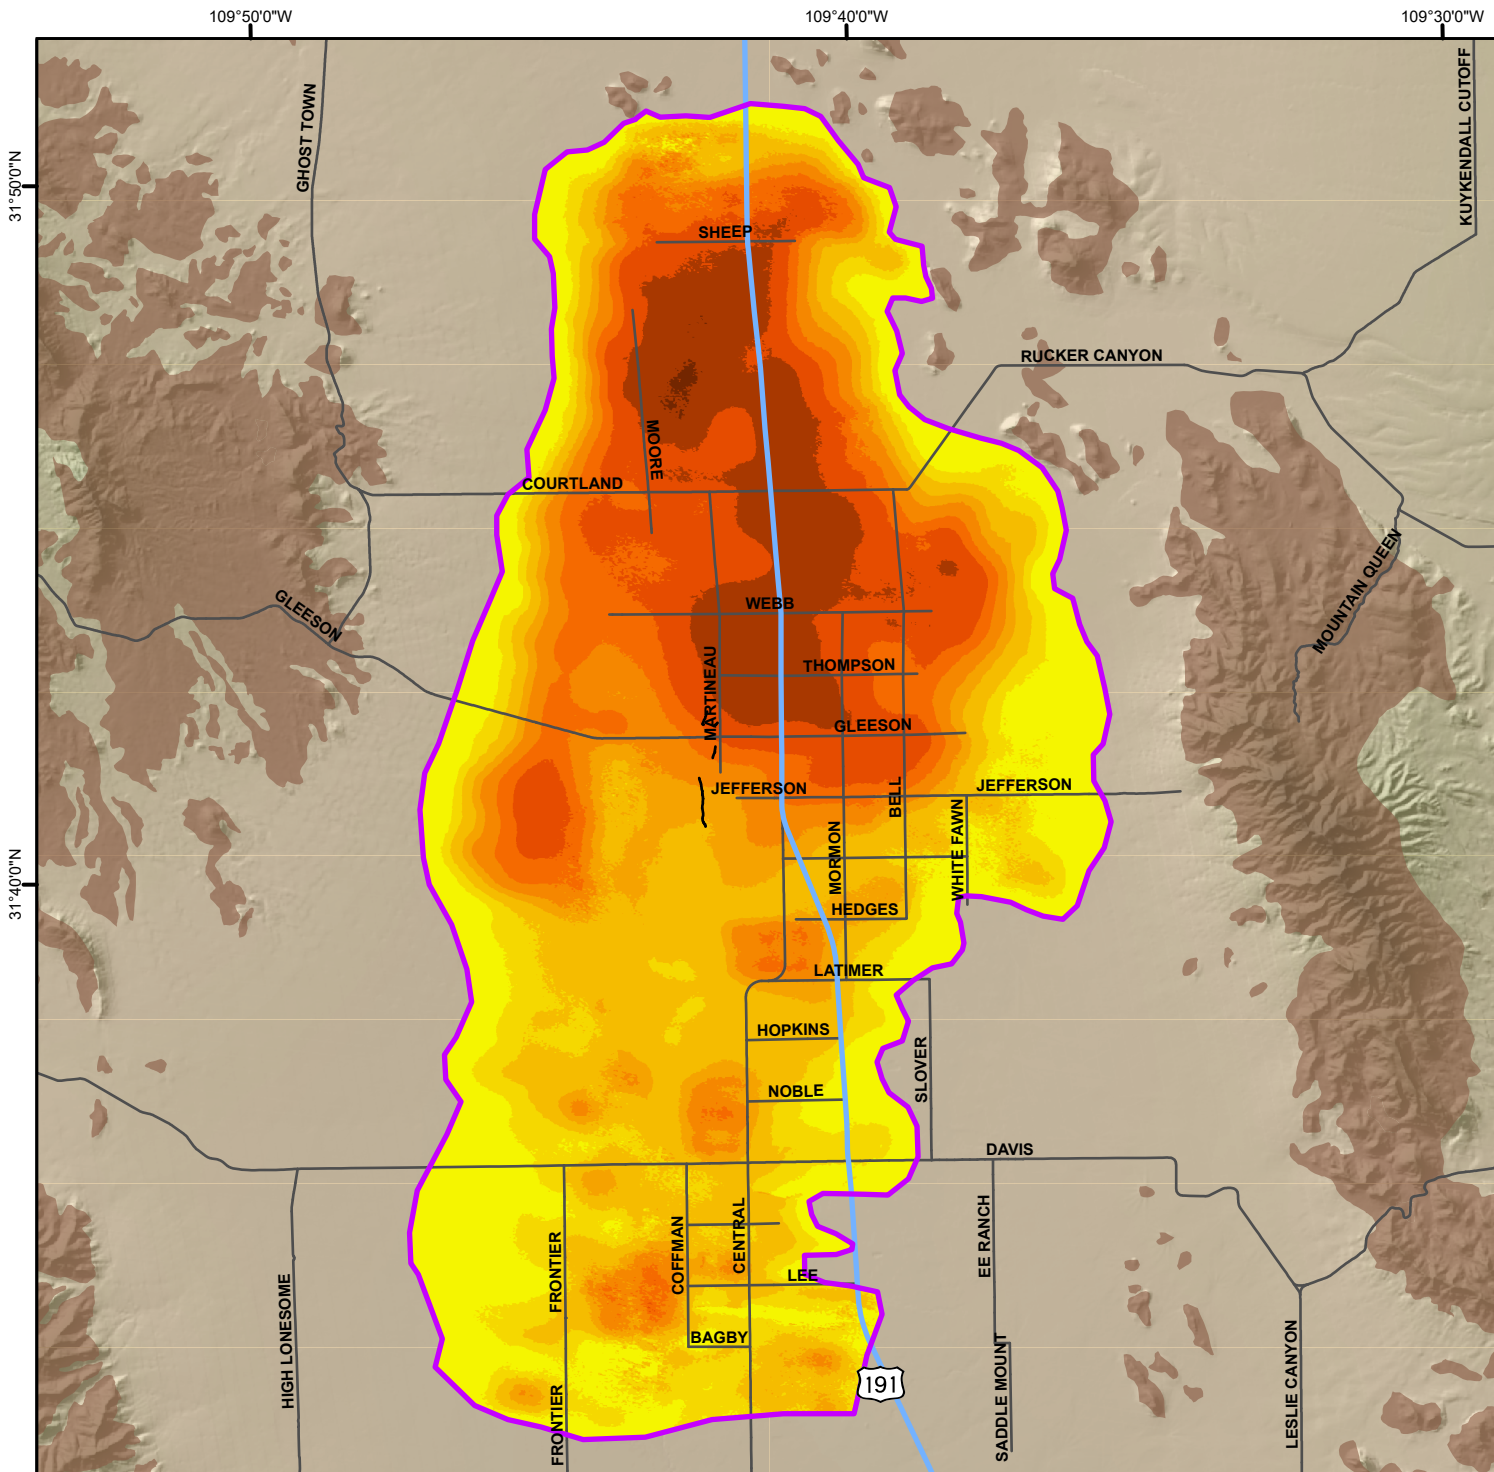
Decorrelation (white areas) are areas where the phase of the received satellite signal changed between satellite passes, causing the data to be unusable. This occurs in areas where the land surface has been disturbed (i.e. bodies of water, snow, agriculture areas, areas of development, etc).

Earth fissures were mapped by the Arizona Geological Survey.
 For information on earth fissures visit: www.azgs.az.gov/EFC
